Case Study: Collision Awareness Solution for Hitachi Shovels

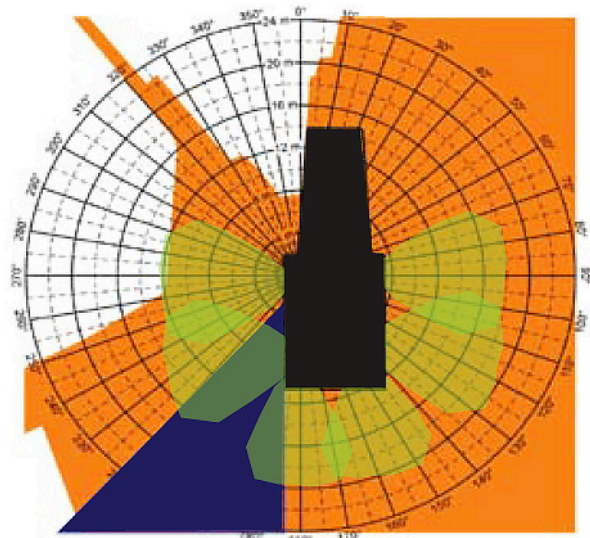
Shovel radar solution blind-spot diagram

APS proposed the install of the PreView Plus Sentry system, which consisted of a 7" monitor, 4 cameras and 6 x Sentry sensors (two sensors were installed to each side of the machine and two sensors were installed to the rear of the machine). PreView Plus cameras were mounted on the left and right of the machine and two cameras were mounted to the rear. This provided a 10m detection zone along both sides and rear corners of the machine to provide visual and audible alerts to the shovel operator, advising them if a haul truck or other obstruction is parked in the exclusion zone.

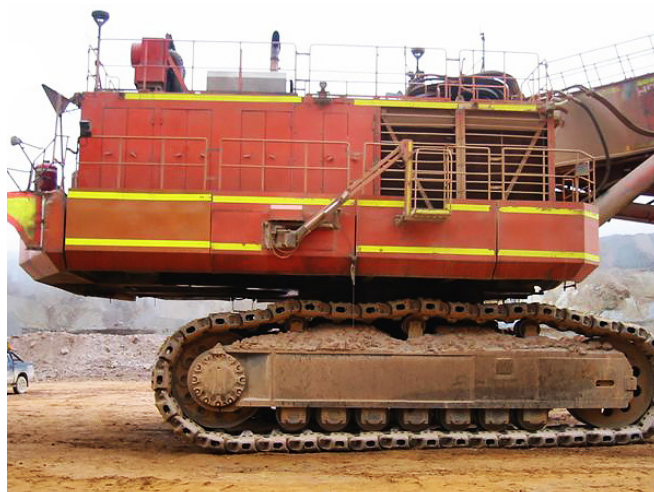
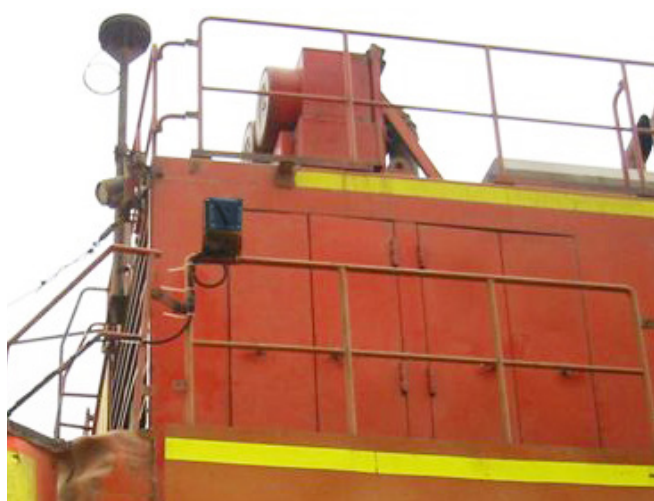
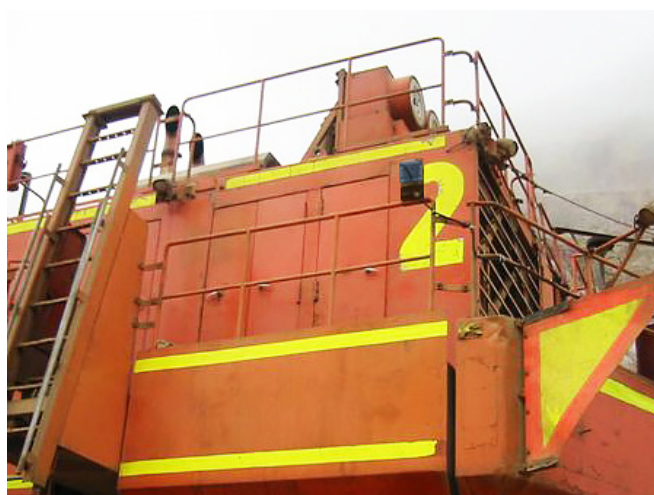
Shovel
 Blind Spot
 Mirror Visibility
 PreView Coverage Area
