Case Study: Collision Awareness Solution for Komatsu 830E

Project Scope: APS was tasked to develop a collision awareness solution with an integrated camera and monitor configuration.

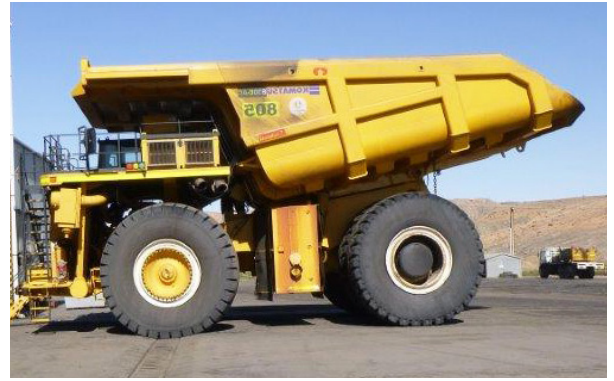
PreView Sentry

Customised Implementation: The front RH corner was fitted with 3 x Sentry sensors, while the rear of the truck was fitted with 1 x Sentry X sensor due to the narrower radar beam pattern. A 7" monitor was installed in the cab to view the 2 front / RH corner, and single rear camera to minimise blind spots.
